RIVER AUX VASES BASIN
BUTTERFLY AND RAINBOW LAKES
STE. GENEVIEVE COUNTY, MISSOURI

MISSOURI INVENTORY NOS.
BUTTERFLY LAKE MO. 30501
RAINBOW LAKE MO. 30641

PHASE I INSPECTION REPORT
NATIONAL DAM SAFETY PROGRAM

SEPTEMBER 1978

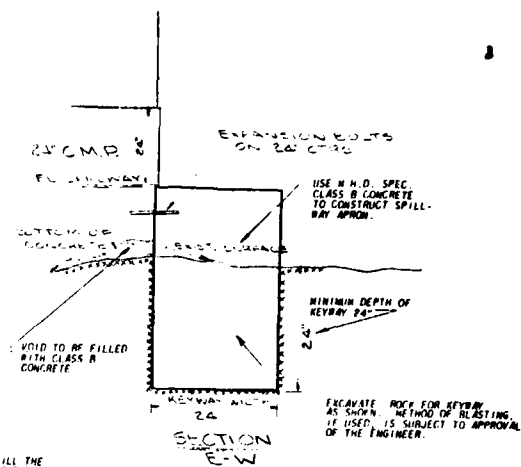
1. FILLING VOID BETWEEN ROCK AND SPILLWAY WITH CONCRETE.
2. EXCAVATING KEYWAY IN ROCK AS DIRECTED BY THE ENGINEER.
3. CONSTRUCTING CONCRETE APRON KEYED INTO REDROCK, WITH ANCHORS TO EXISTING SPILLWAY (EXPANSION BOLTS).

- THE CONTRACTOR SHALL FILL THE VOID BETWEEN THE ROCK AND THE EXISTING CONCRETE WITH CLASS B CONCRETE IN A MANNER SATISFACTORY TO THE ENGINEER. ALL REINFORCED ROCK MATERIAL AND DEBRIS SHALL AS FAR AS POSSIBLE BE REMOVED FROM THE CAVITY FOR ROCK REMOVAL NORTH OF EXISTING STRUCTURE. EXTENSION OF STRUCTURE, AND OTHER DETAILS, SEE SECTION F-9.
